**Re: 2 Toronto Street, Barrie - Cladding & Balcony Repairs  
Final Review  
Project No.: 300052350**

A site review was conducted at 2 Toronto Street, Barrie on January 11, 2022 by Wyatt Poulton of R.J. Burnside & Associates. Attendees visually reviewed the site and identified the following deficiencies and remaining work.

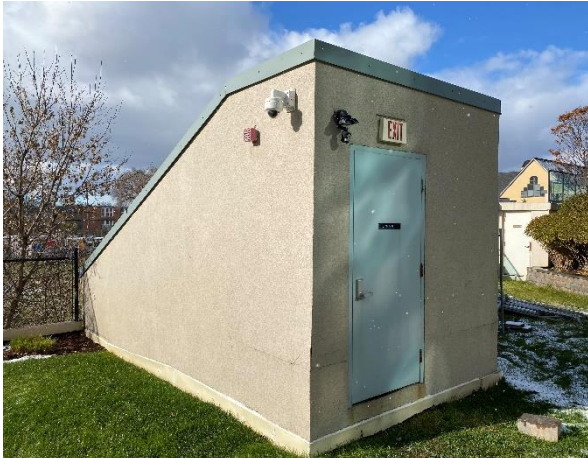
**Photo 1**

- **North-West Exit Stairwell:** The full scope of cladding repairs at the north-west exit stairwell structure on the garage podium has not been completed (Photo 1). Contractor plans to return in spring 2022 to complete the repairs when the weather permits.

North-west stairwell structure incomplete.

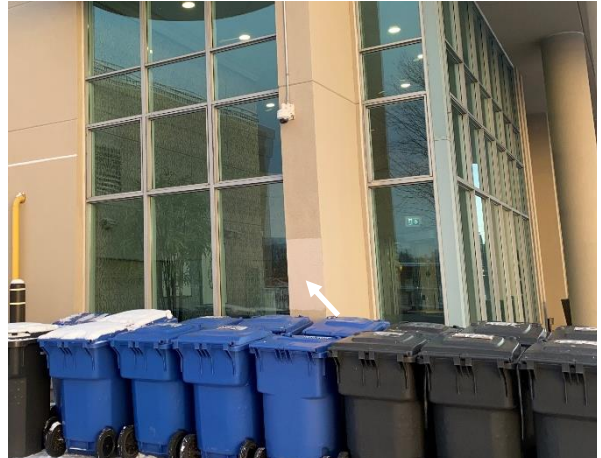
**Photo 2**

- **At-Grade Cladding Repairs:** Localized at grade cladding repairs and coating work at the south-east loading bay area has not been completed (Photos 2 to 5). Contractor plans to return in spring 2022 to complete the repairs and coating work when the weather permits.

Area of incomplete coating work.

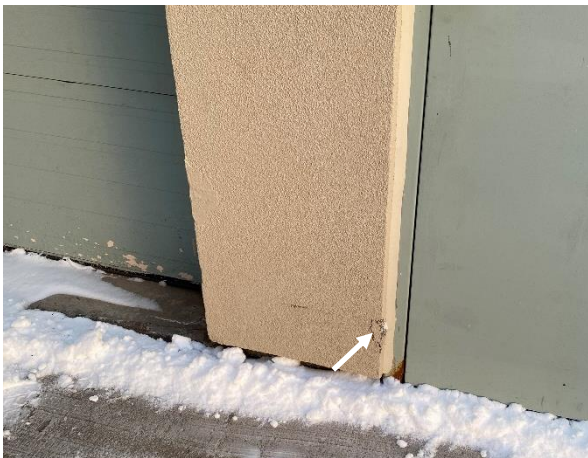
**Photo 3**

Example of outstanding patch repair.

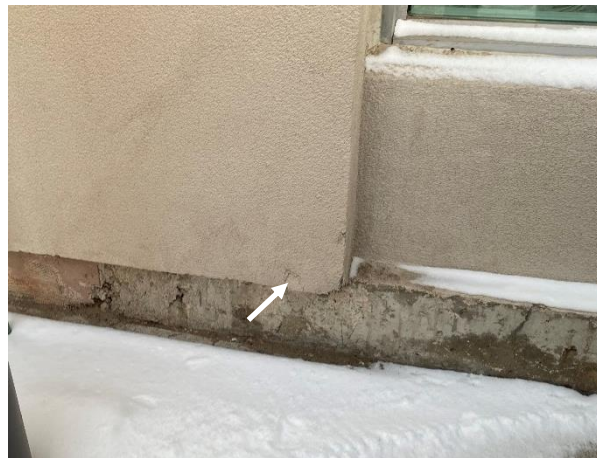
**Photo 4**

Example of outstanding patch repair.

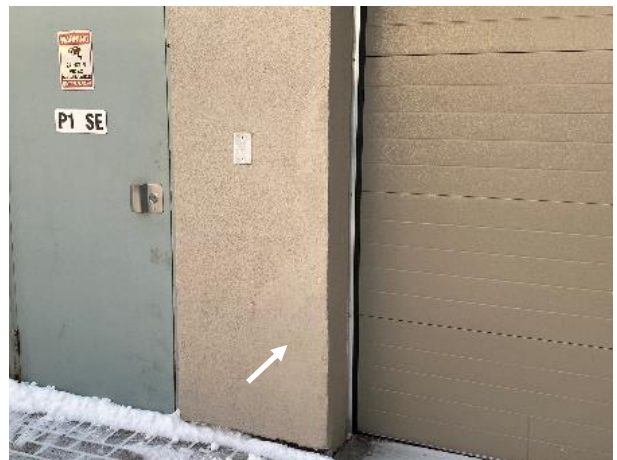
**Photo 6**

- **Parking Garage Entrance Coating Work:** Localized areas of finish coat repairs adjacent to the parking garage overhead door and the loading bay have an inconsistent finish (Photos 6 to 8). Contractor plans to return in spring 2022 to reapply the stucco finish coat when the weather permits.

Example of inconsistent stucco finish.

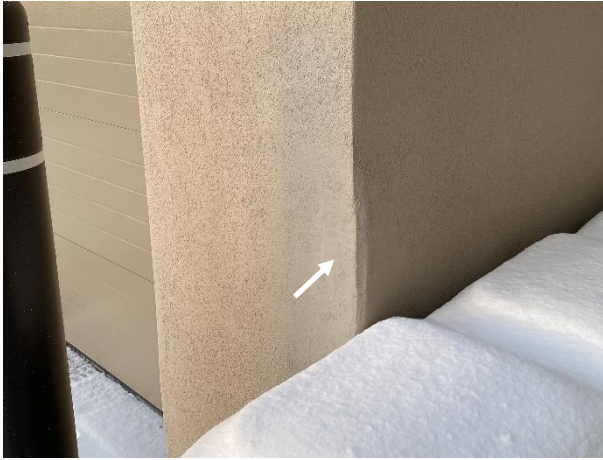
**Photo 7**

Example of inconsistent stucco finish.

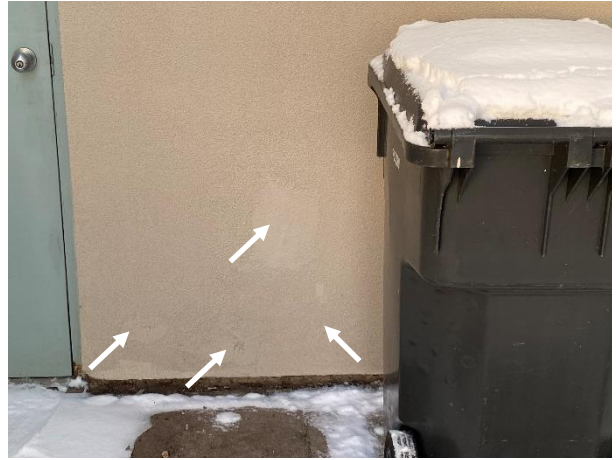
**Photo 8**

Example of inconsistent stucco finish.

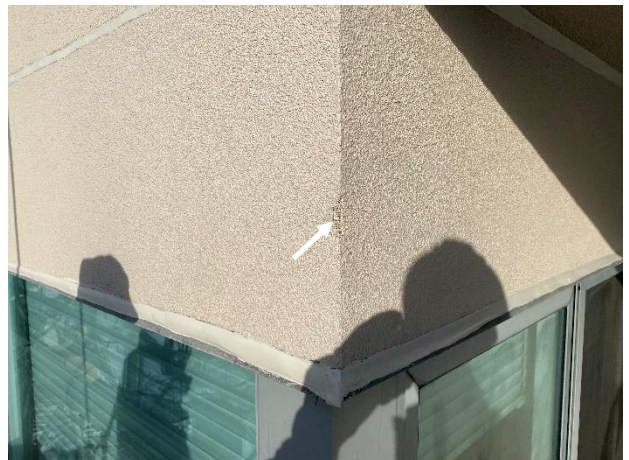
**Photo 10**

- **Suite 1203 Stucco Repair:** The stucco finish is damaged at the wall corner located above and south of the sliding glass door at Suite 1203 (Photo 10). The contractor plans to repair this area of stucco in the spring of 2022 when the weather permits.

Damaged stucco finish at Suite 1203.

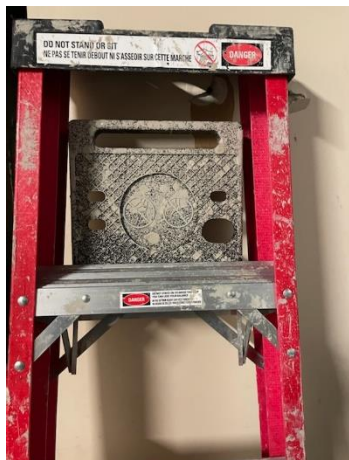
**Photo 11**

- **Mechanical Room Step Ladder:** The property manager reported that the step ladder located in the 2 Toronto Street mechanical room was damaged (Photo 11). The contractor plans to replace the step ladder on January 21<sup>st</sup>.

Mechanical room step ladder.
