FINAL INSPECTION DOCUMENT 203473 FI

Site Address: 140 Church street, Warkworth

On August 29th, 2022, Solucore Inc. performed a final inspection of the elevator at 140 Church Road in Warkworth Ontario. The purpose of the inspection was to perform a review under the provision of the specifications requiring inspection by the consultant prior to releasing the elevator to the public and to ensure that the installation is as stipulated in the specification.

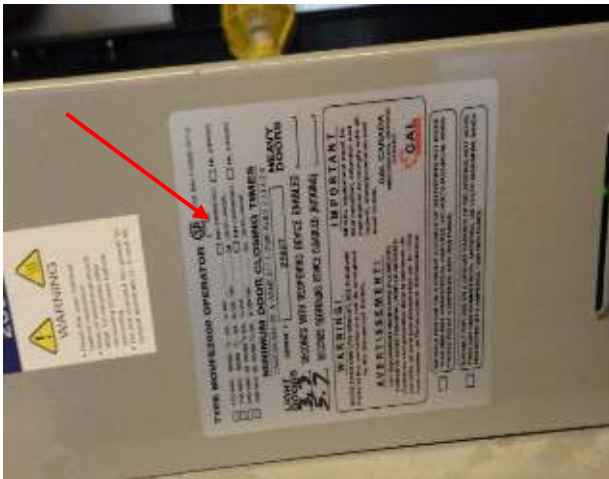
Photo 1

1. Fill out door operator Tag. – **Photo 1**
2. Put plug in car top trough. – **Photo 2**
3. Adjust smart tork so the white dot in inline with cable. - **Photo 3**
4. Adjust valve so it doesn't by pass basement landing.
5. Adjust hoistway access on 1st floor. - **Photo 4**
6. Adjust belt on door operator so belt is aligning top on bottom. - **Photo 5**
7. Increase the Door close speed.

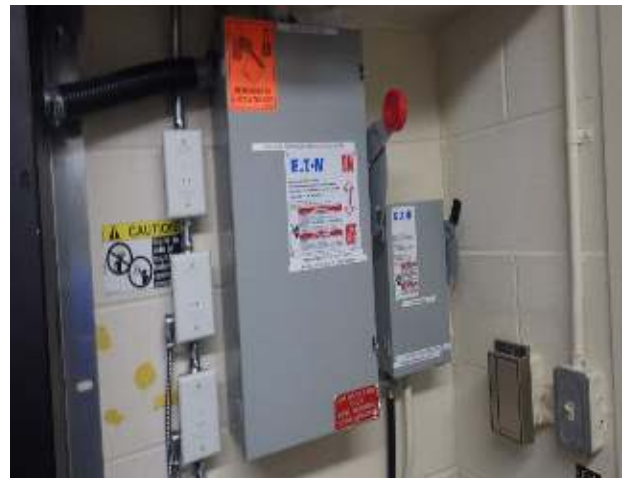
Photo 6

1. Provide three (3) sets of operation manuals to the owner as per the specification.
2. Provide 5 complete sets (a set contains two keys) of keys (for each key type) to the Owner.
3. Provide the client with the required close out documentation as outlined in section 1.4 "Wiring diagrams and Manuals upon substantial completion";
4. Submit the clean and cleared TSSA inspection reports on all cars.
5. Label disconnect in machine room. - **Photo 6**

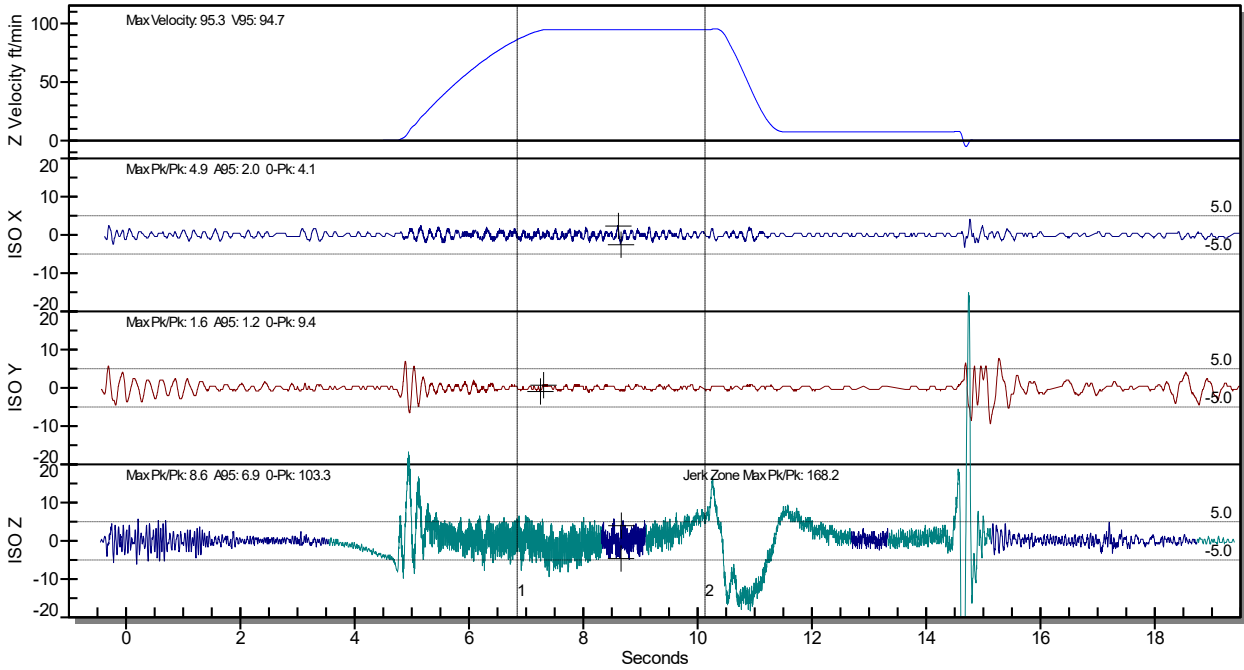
Car UP

Designation:	1	Suggested
Speed Up	95.3	90 - 110 fpm
Speed Down	84.0	80-90 fpm
Operating time up	18	13.2 sec
Operating time down	19	13.2 sec
Door open time	3.5	2.5 sec
Door closed time	3.6	4.0 sec
Car call dwell time	2.8	2.0 – 2.5 sec
Hall call dwell time	5.4	3.5 – 4.5 sec
Door closing force	29	≤30 lbs
Levelling accuracy	+/- 1/8"	+/- 1/8"
X A95	4.9	6mg
Y A95	1.6	6mg
Z A95	5.7	6mg

Units: mill(g) File: LG1326O9.VE6 04:48:19 03/02/03

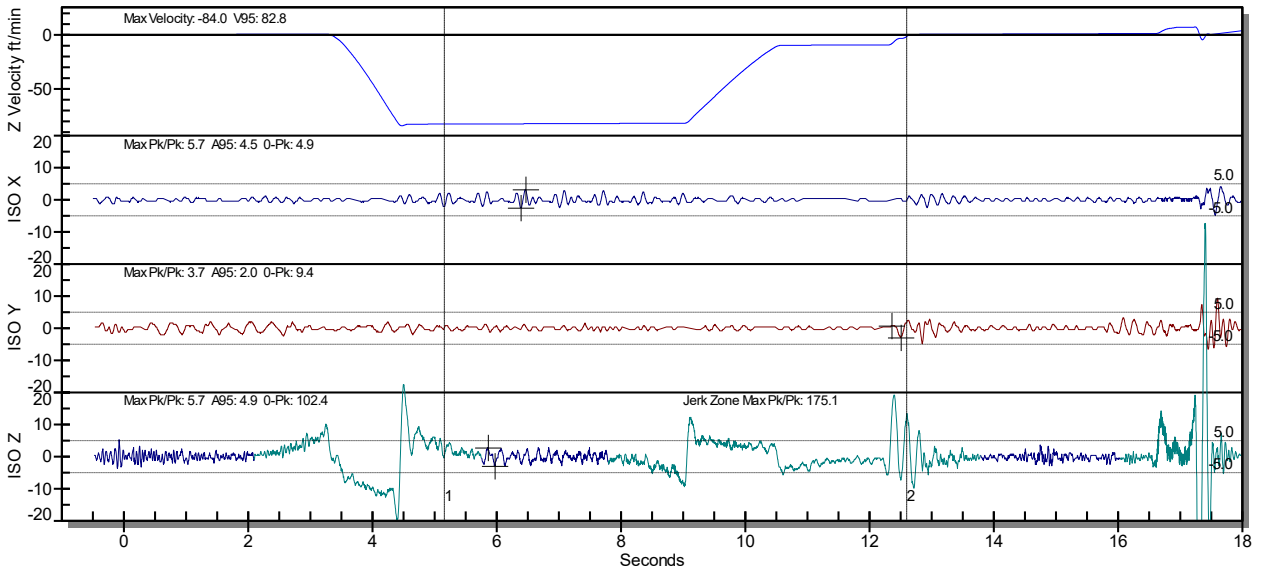
Car Down

Units: mill(g) File: LG1326NO.VE6 04:47:36 03/02/03
